#### **TEST REPORT**

**Report No.**: D9352.02-121-24

**PRODUCT TYPE**: Window Film **SERIES/MODEL**: Ceramic Series

**TEST METHOD**: ASTM E 84-11a, Standard Test Method for Surface Burning Characteristics of Building Materials

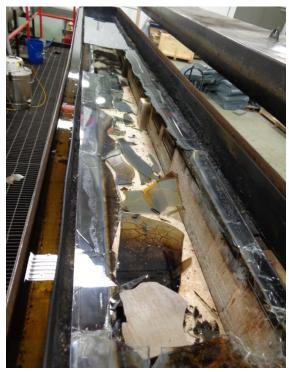
Photo No. 2 Specimen Mounted (Post-test)

Observations		
Ignition Time:	02:22 (Min:Sec)	
Max Flame Front Advance:	0.0 Feet	
Time to Max Flame Front:	00:00 (Min:Sec)	
Max Temp At Exposed T/C:	586.1°F	
Time To Max Temp:	09:55 (Min:Sec)	
Dripping Observed:	No	
Flaming On Floor Observed:	No	
After Flame Top Observed:	No	
After Flame Floor Observed:	No	
Sagging Observed:	No	
Delamination Observed:	02:51 (Min:Sec)	
Shrinkage Observed:	No	
Fallout Observed:	01:48 (Min:Sec) Fallout started at	
	the beginning of test specimen	
	and continued down the specimen	
	for 12 feet.	
Cracking Observed:	00:09 (Min:Sec)	
Observations After the Test:	None
